Appendix F

Structures Inspection Results

FACILITIES CONDITION ASSESSMENT REPORT

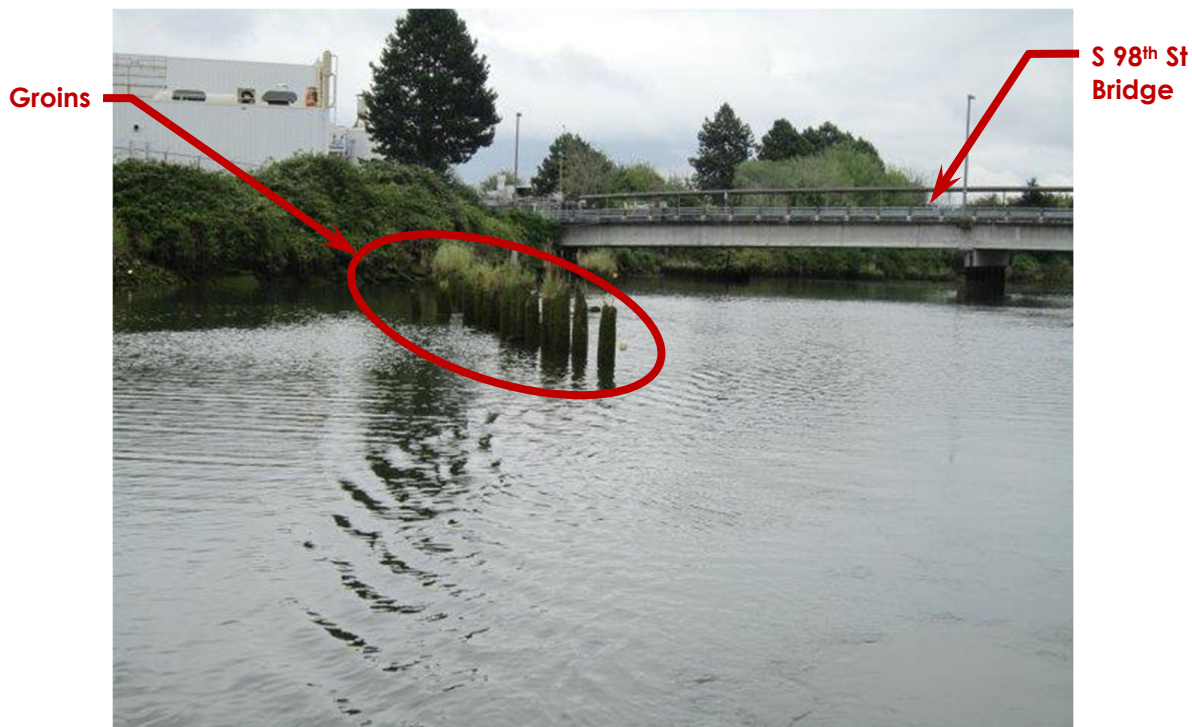
Photo ST07-11: Groins North of Bridge (Looking Southeast)

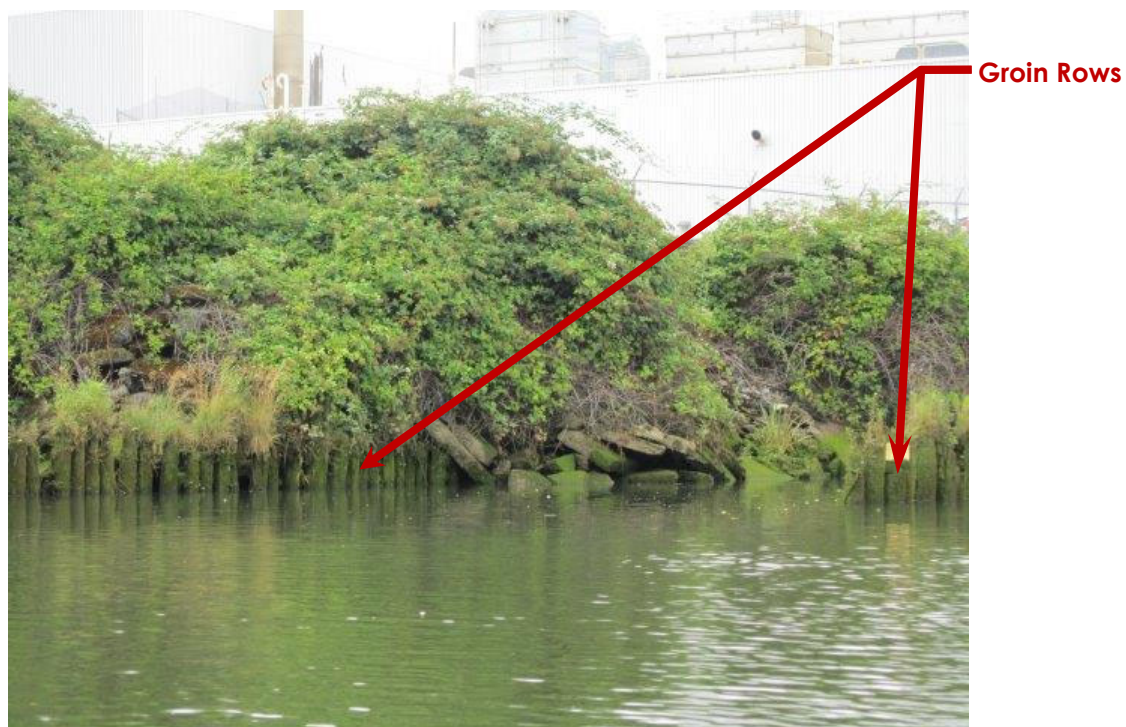
Photo ST07-12: Groins and Embankments North of Bridge

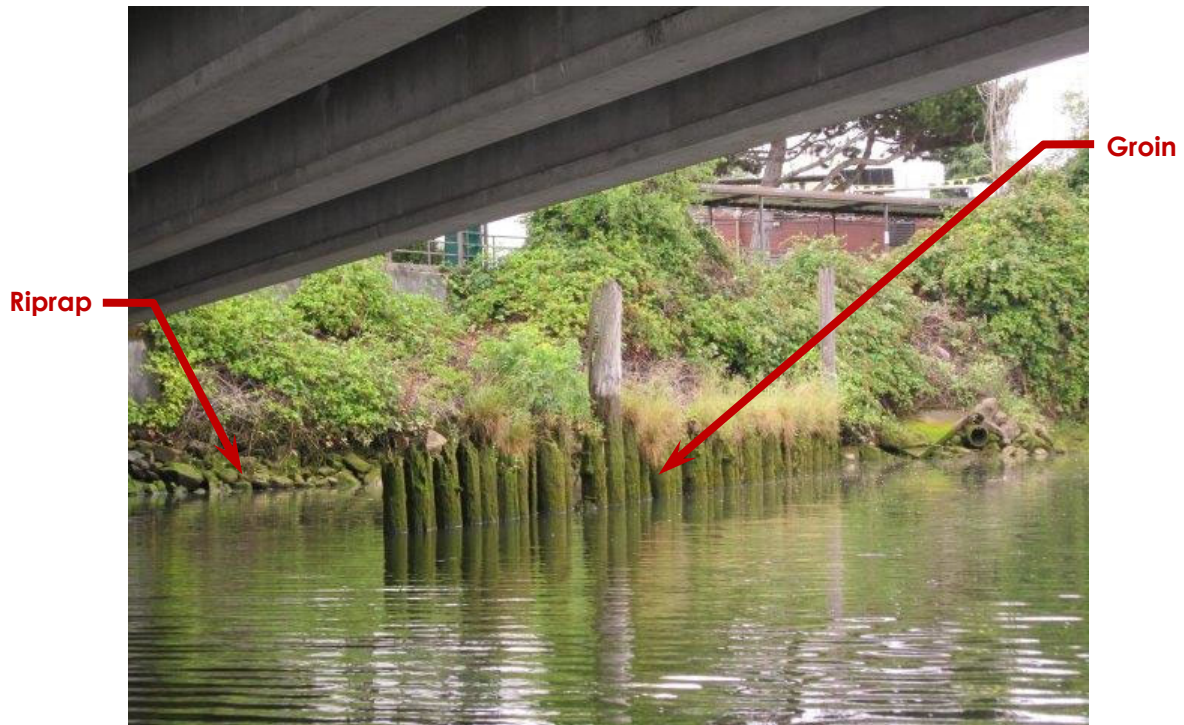
Photo ST07-13: Groins and Embankment South of Bridge

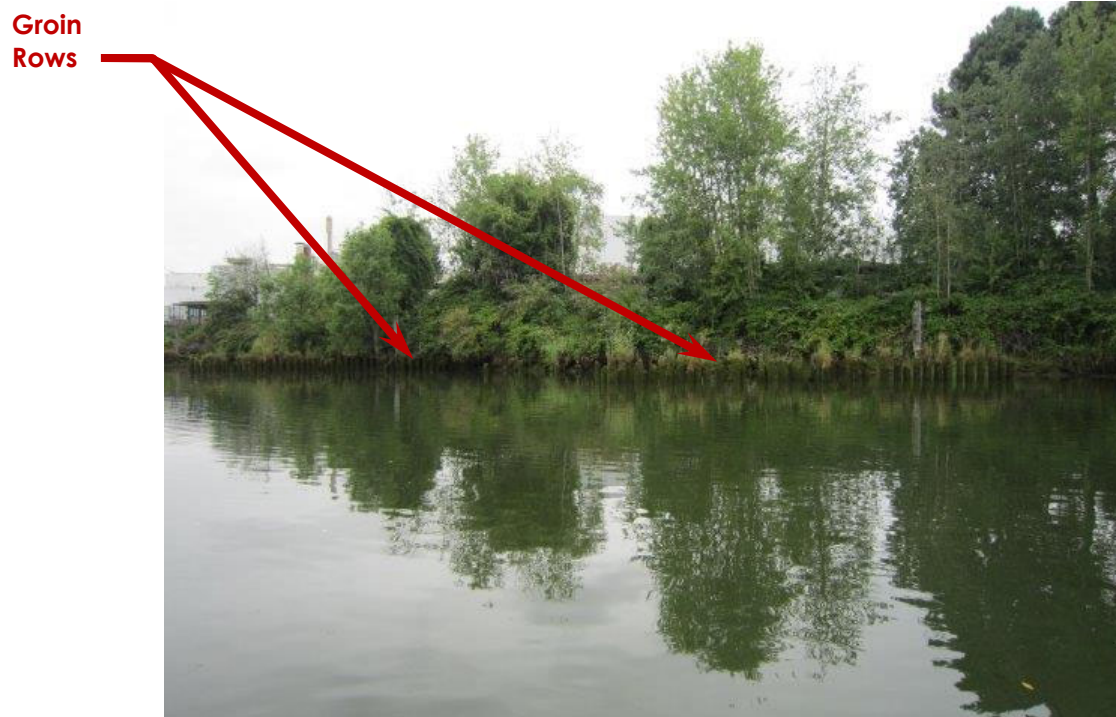
Photo ST07-14: Groins and Embankment South of Bridge

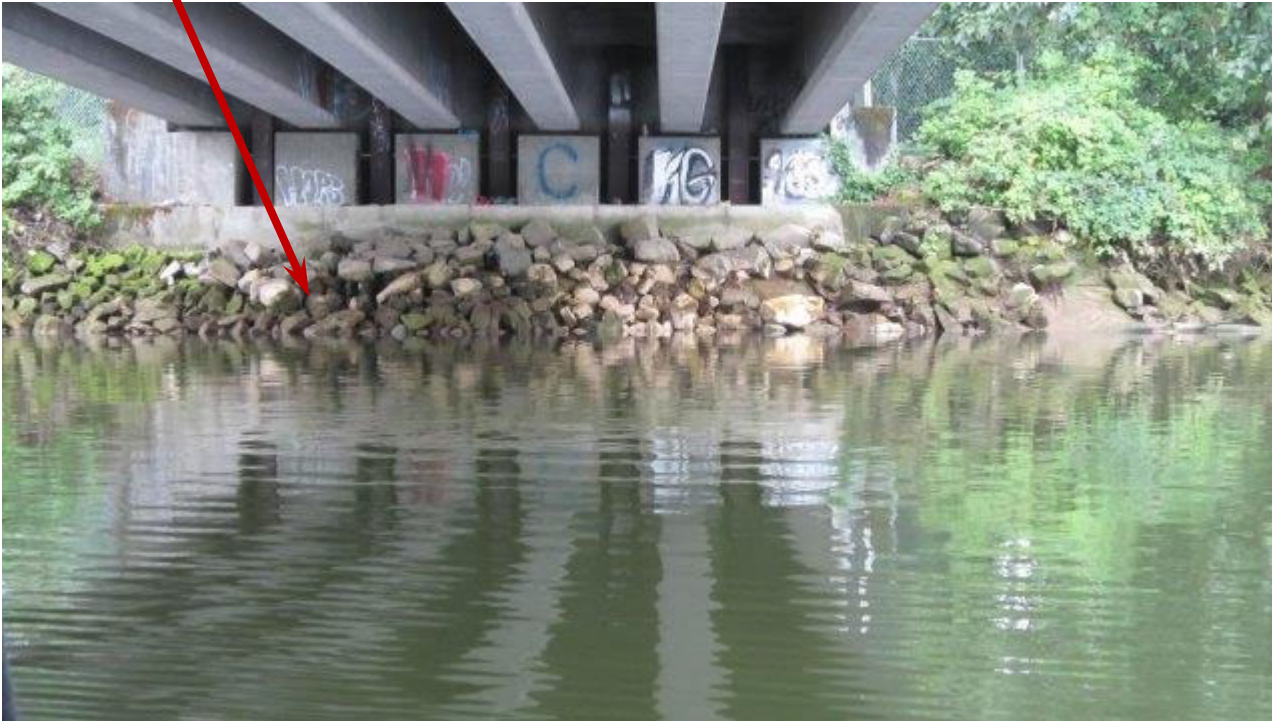
- Three (3)-span concrete girder bridge (Photo 1).
- East and west concrete abutments protected with riprap (Photos 2 and 3).
- Two (2) bents in the navigational channel each consisting of seven (7) steel piers and concrete cap beam (Photos 4 and 5).
- The concrete surface of the abutments and girders appears to be in good condition (Photos 2 to 4).
- The surface of the steel piers exhibits scattered rust and corrosion (Photos 4 and 5).
- Approximately 12-ft vertical clearance at center spans (1:55pm, July 17, 2020 tide level)

Photo ST08-03: West Abutment

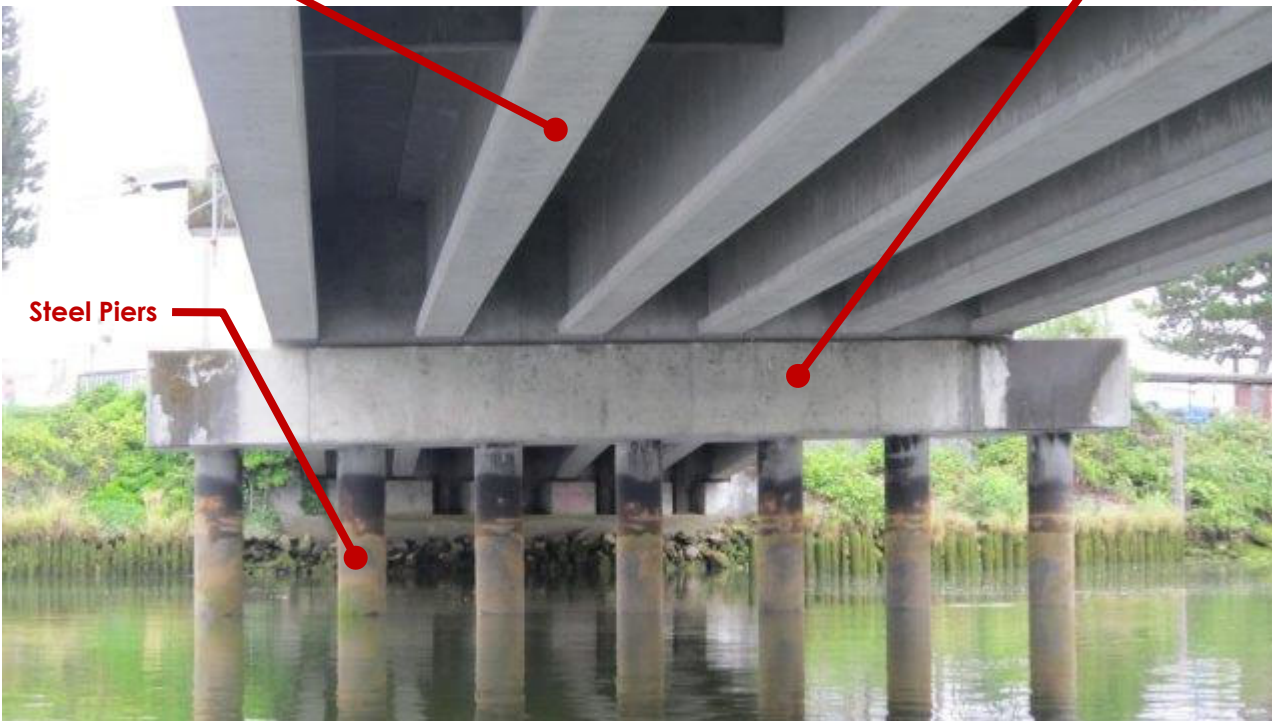
Photo ST08-04: East Bent (Looking East)

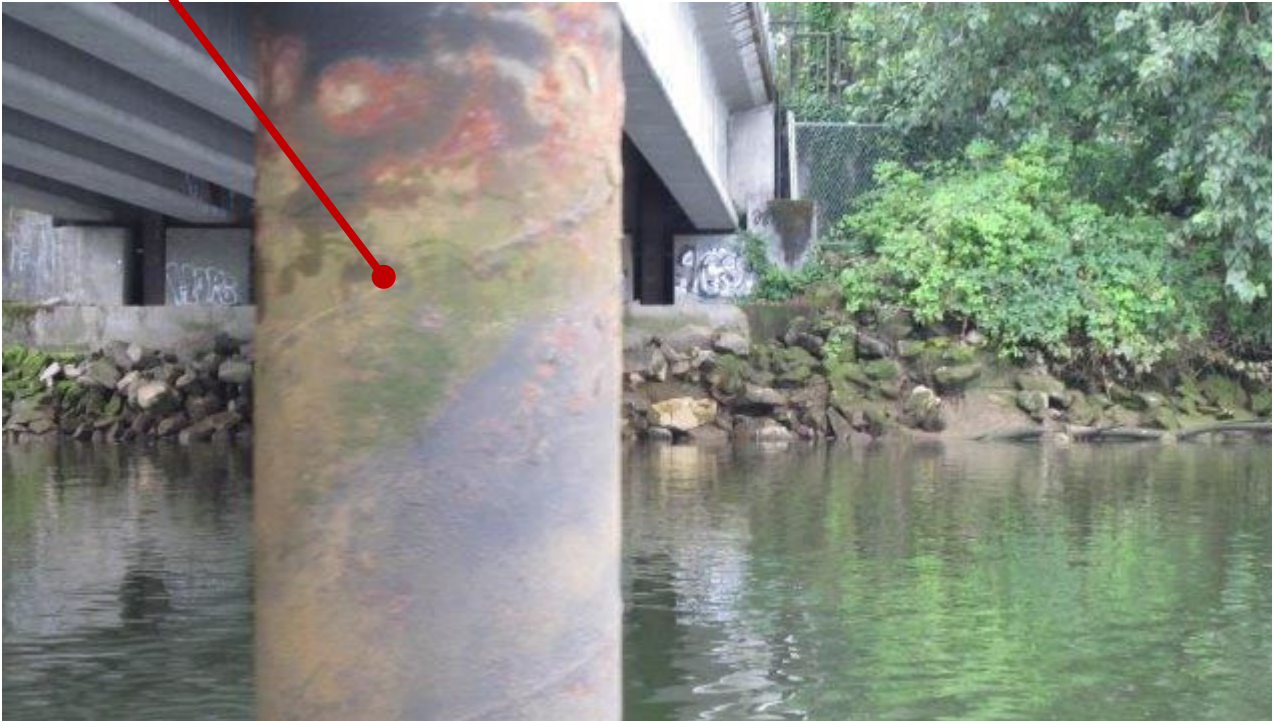
Photo ST08-05: West Bent (Looking West)

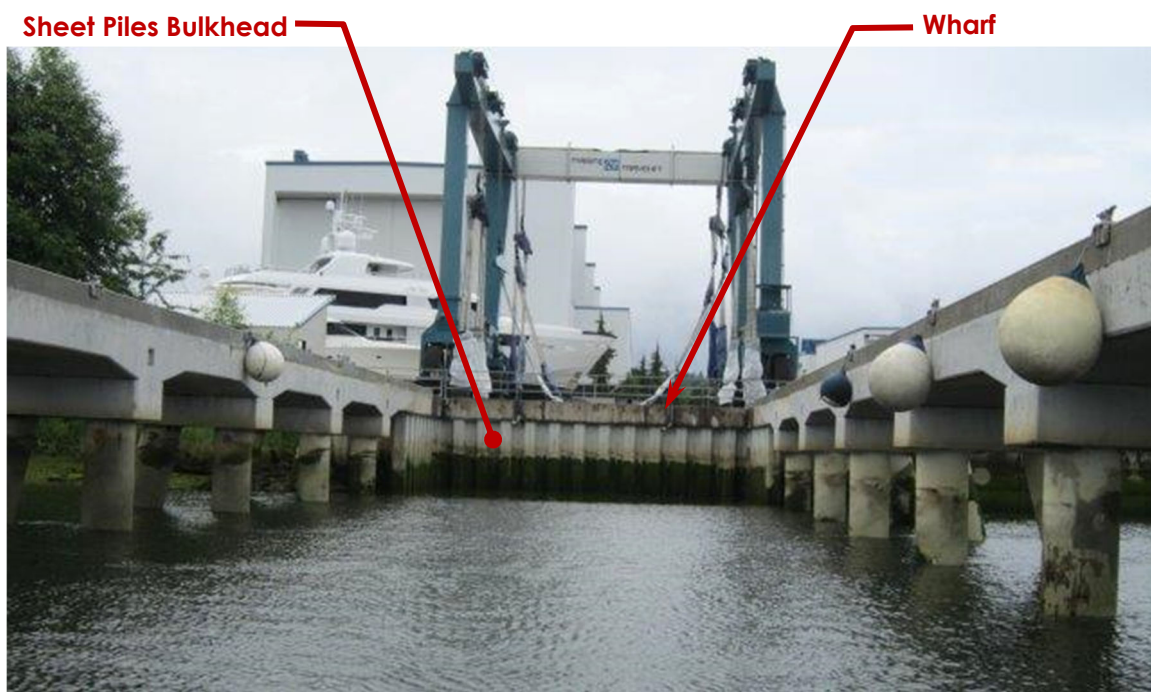
Photo ST12-02: Finger Piers (Looking West)

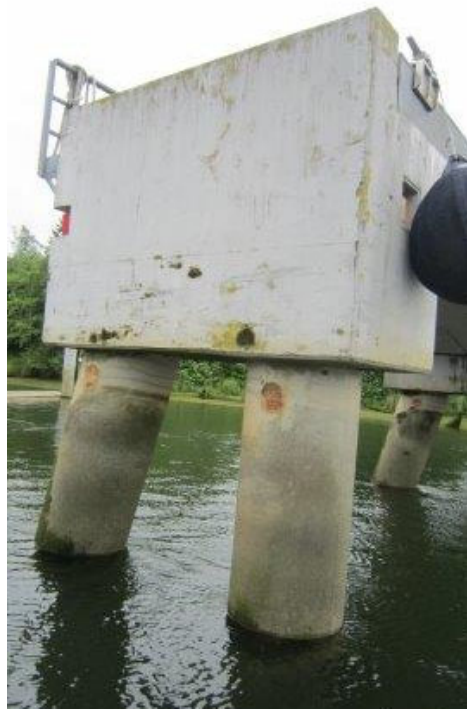
Photo ST12-03: East End Piles and Caps of South Finger Pier

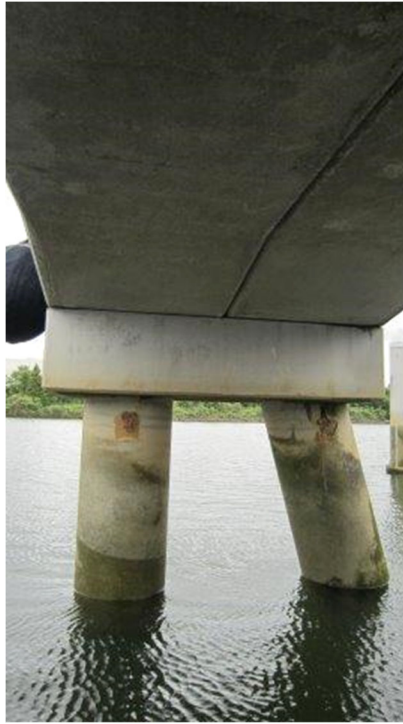
Photo ST12-05: Pile Cap and Pier Decks (Looking West)

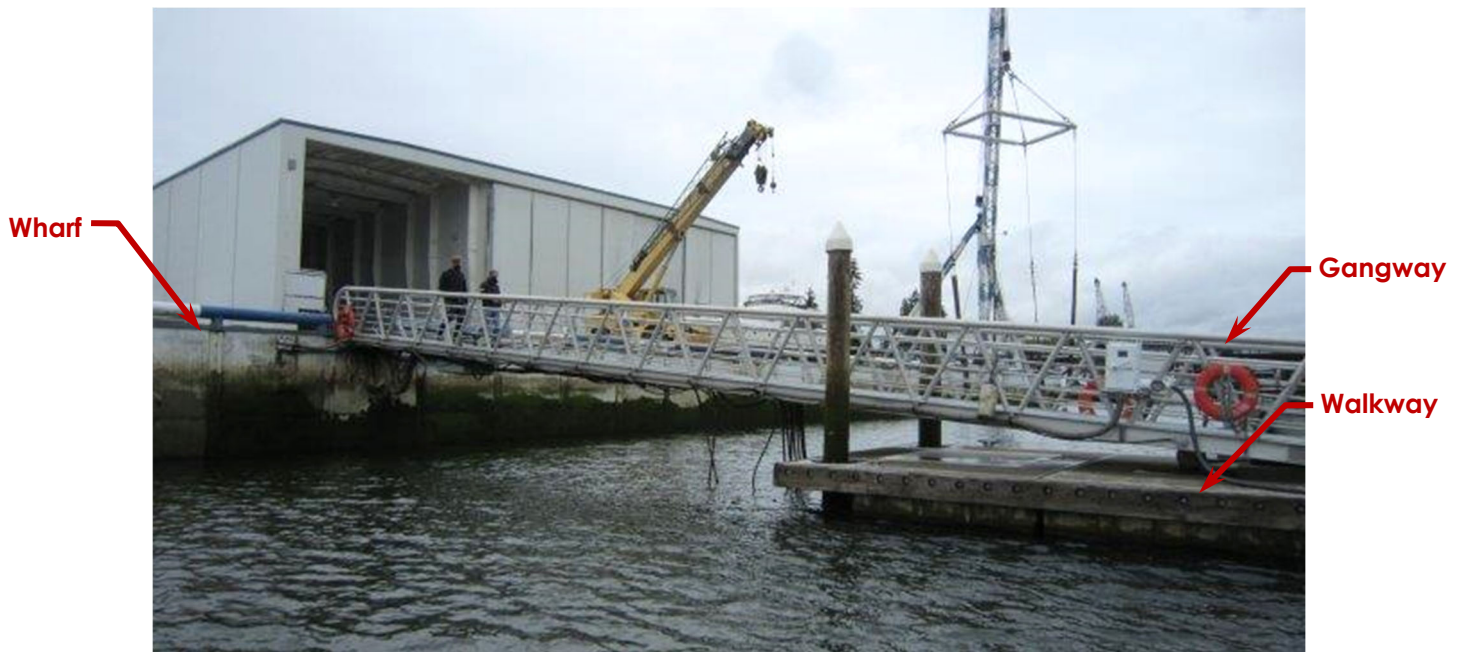
Photo ST12-06: Floating Dock Access Way (Looking North)

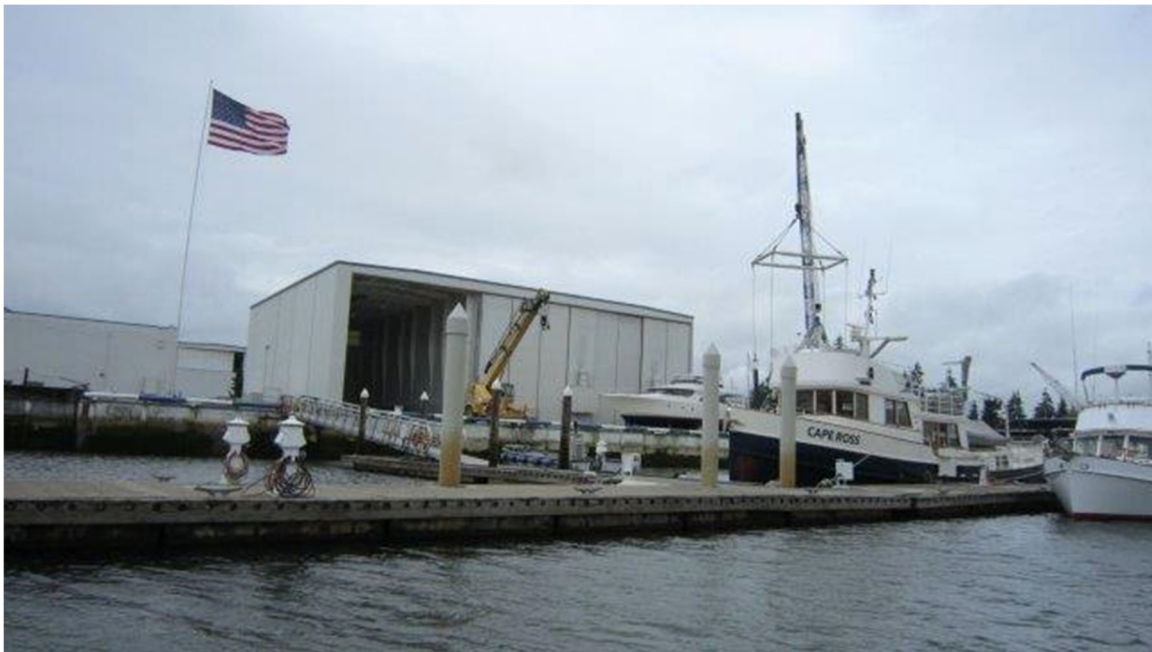
Photo ST12-07: Floating Dock

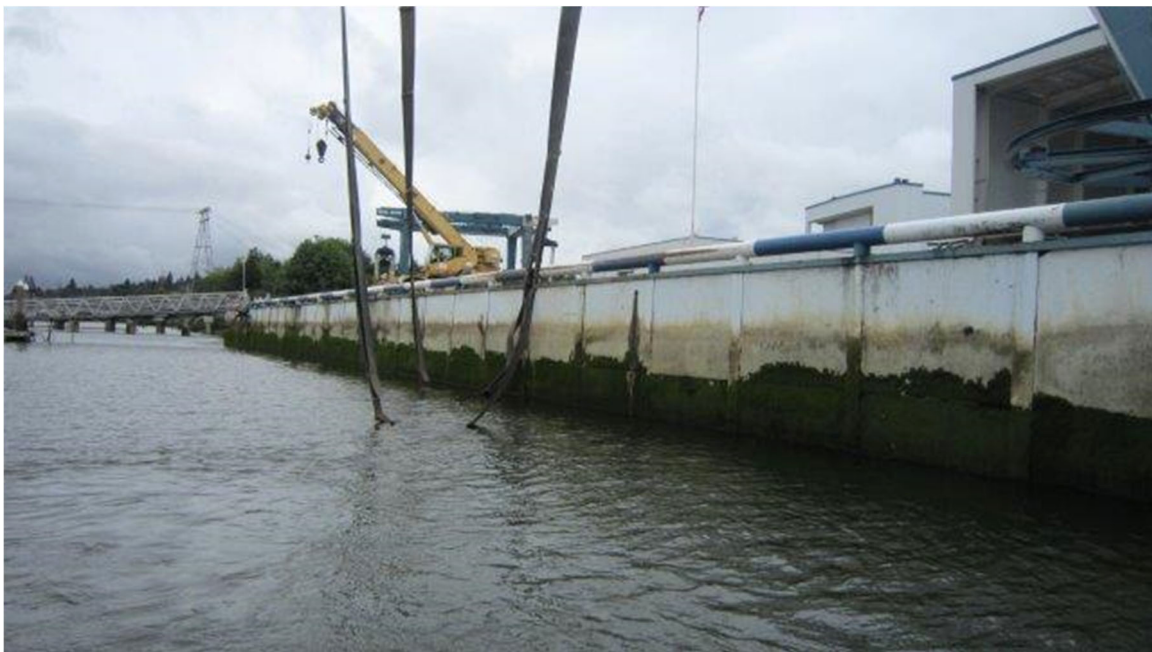
Photo ST12-08: Bulkhead Among Wharf

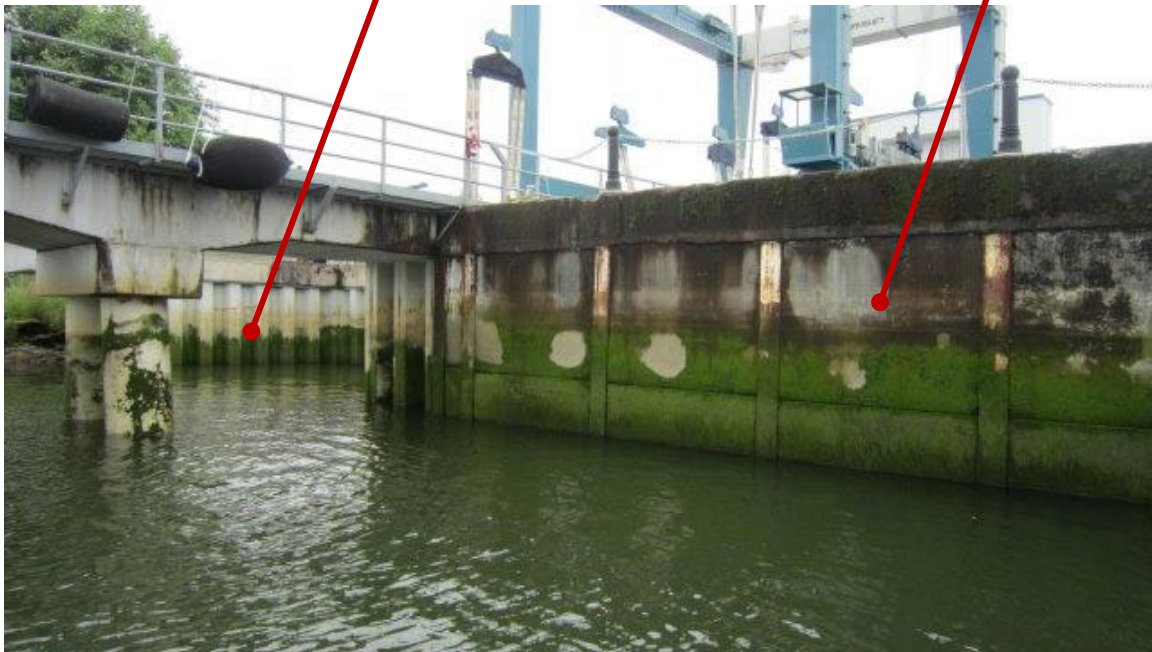
Photo ST12-09: Bulkhead

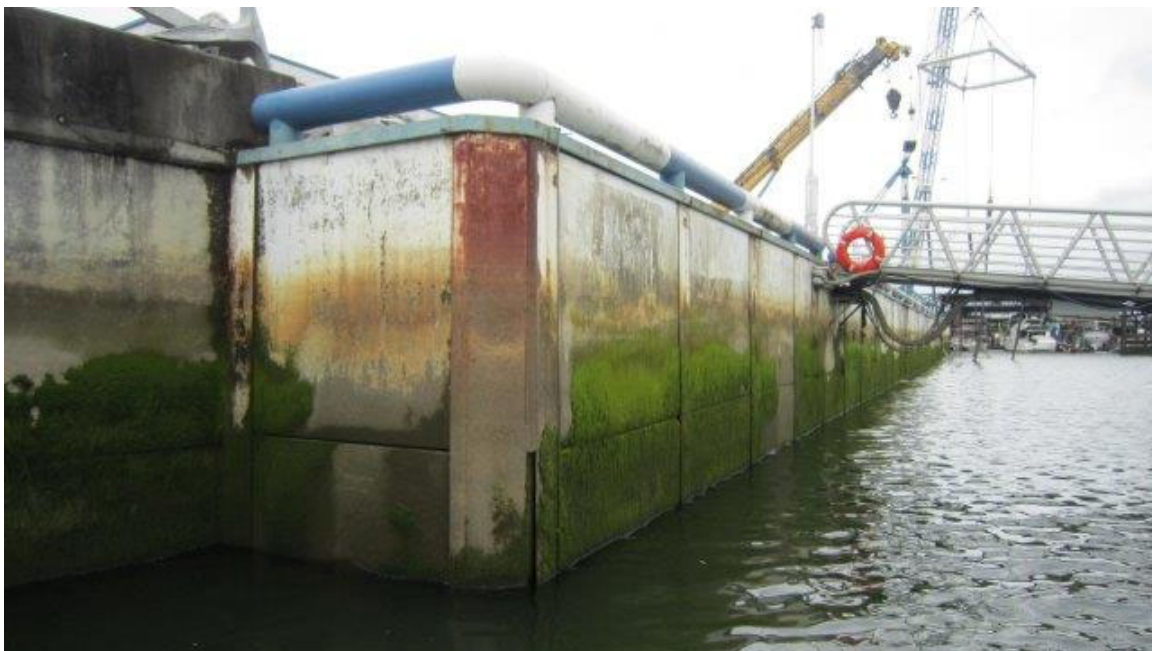
Photo ST12-10: H-Pile Bulkhead (Looking North)

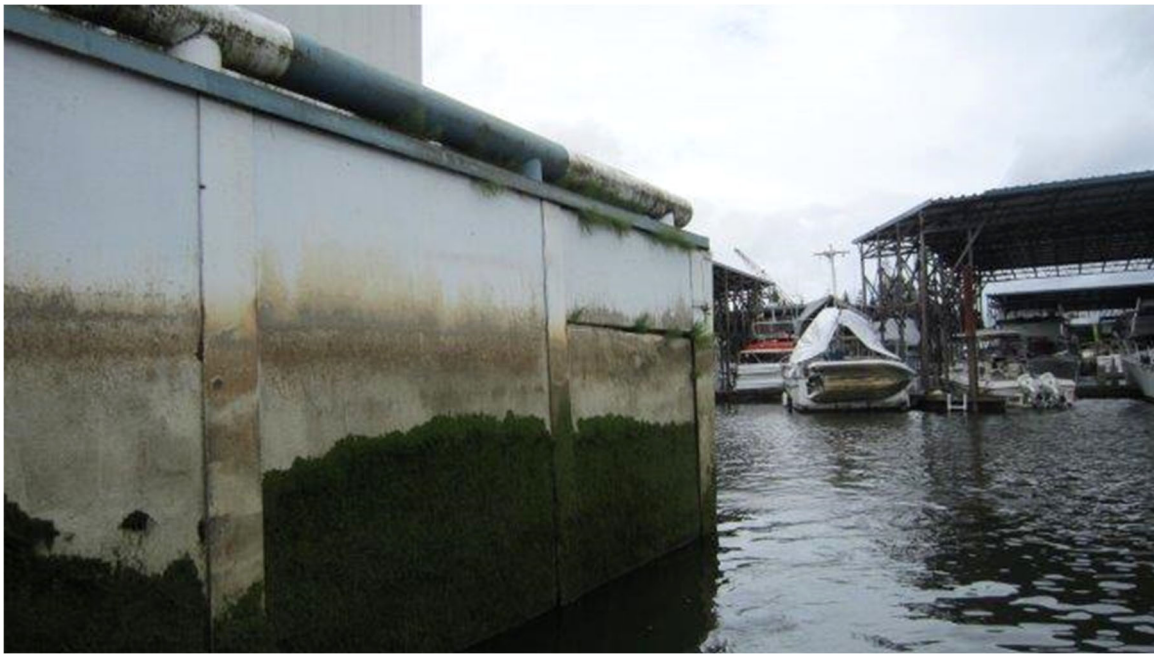
Photo ST12-13: North End Close Up of the H-Pile Bulkhead

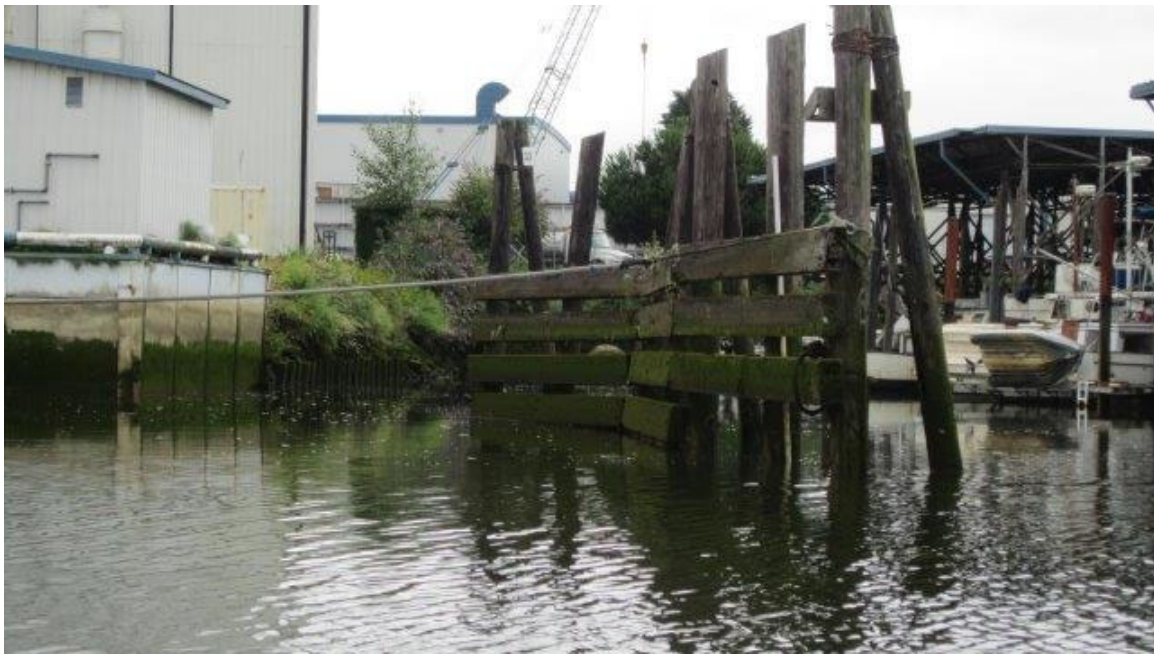
Photo ST12-15: Breakwater

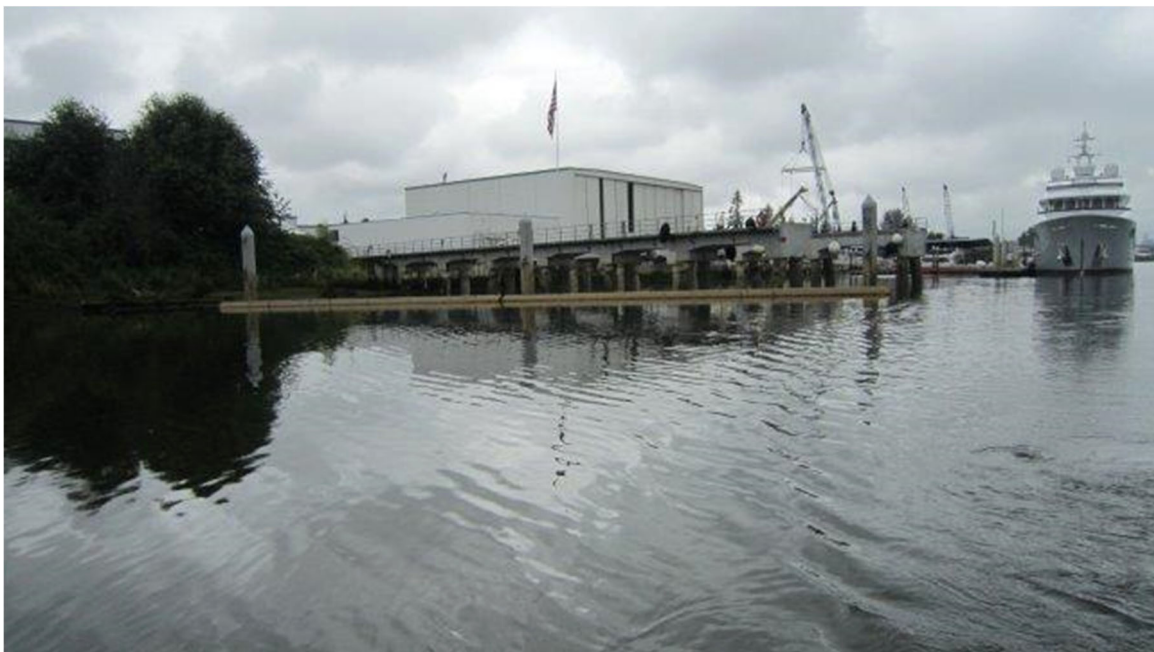
Photo ST12-016: Upstream Debris Deflector

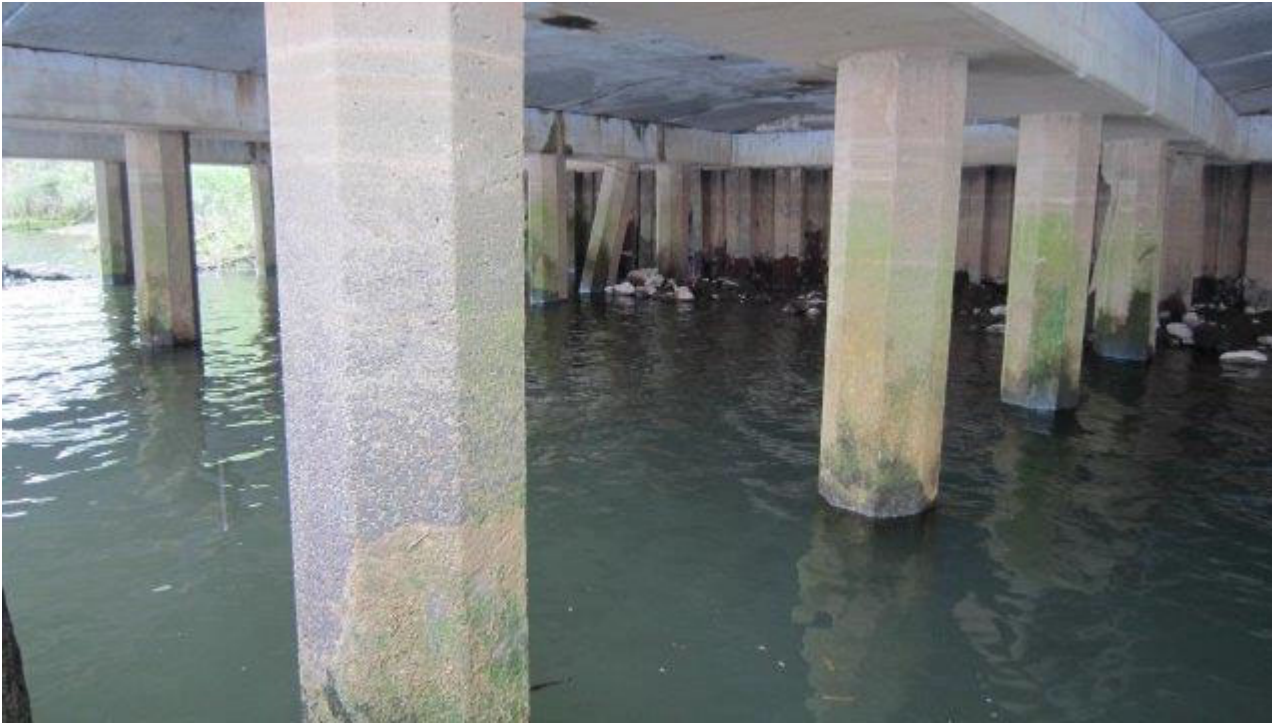
- The concrete surfaces of the pile caps appear to be in good condition. No cracks, spalls, or significant chips were observed (Photos 7 to 11).

- A close observation of the steel sheet pile and concrete cap was not possible. There appears to be moss growth and rust in the wet/dry zone of the sheet pile (Photos 7, 10, 12, 14, and 15).

Photo ST16-07: Concrete Piles (Looking Southwest)

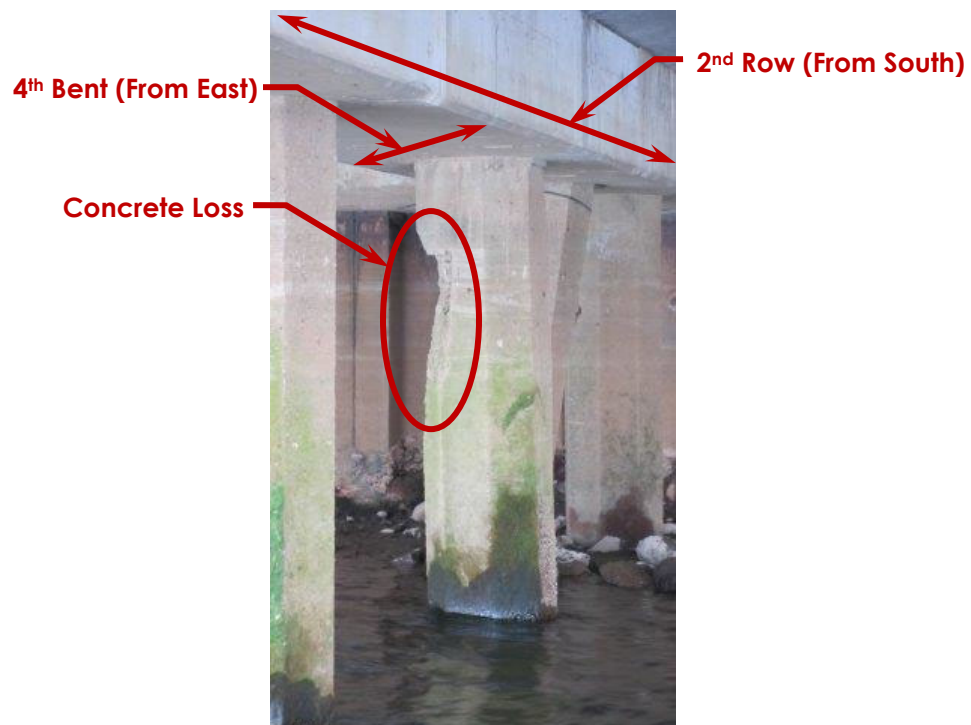
Photo ST16-08: Concrete Pile

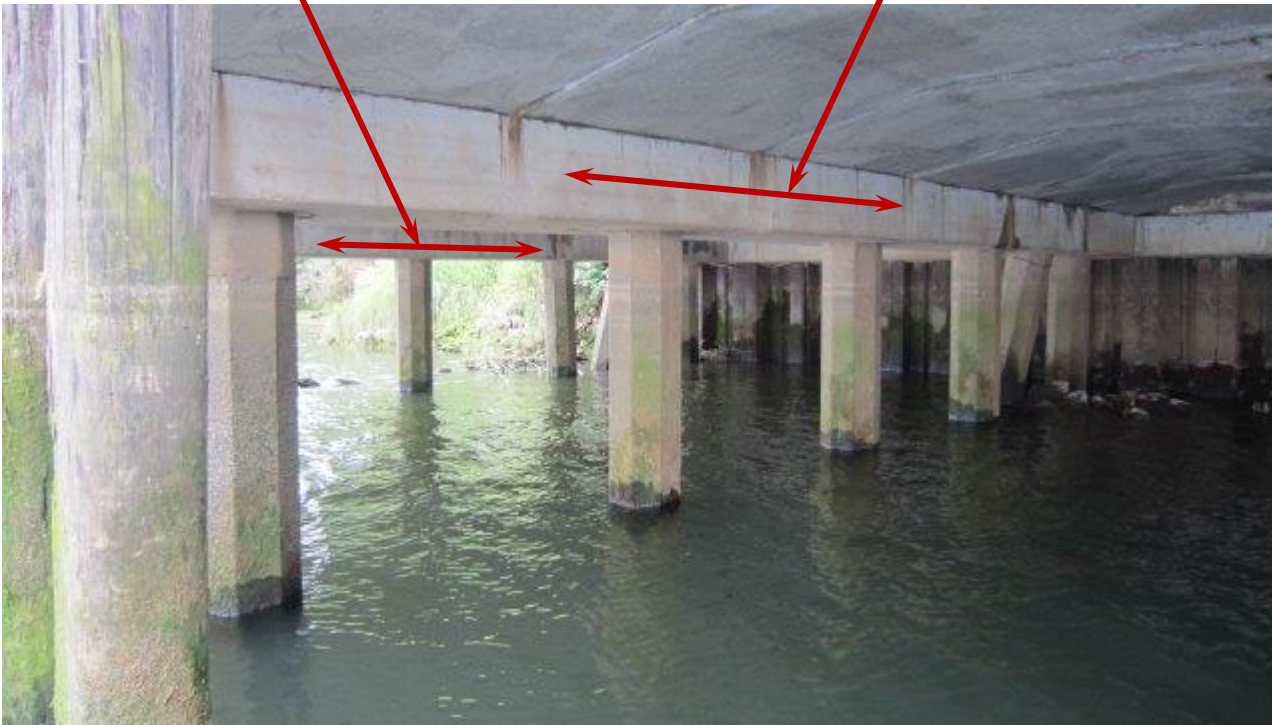
Photo ST16-11: Piles and Pile Caps (Looking Southwest)

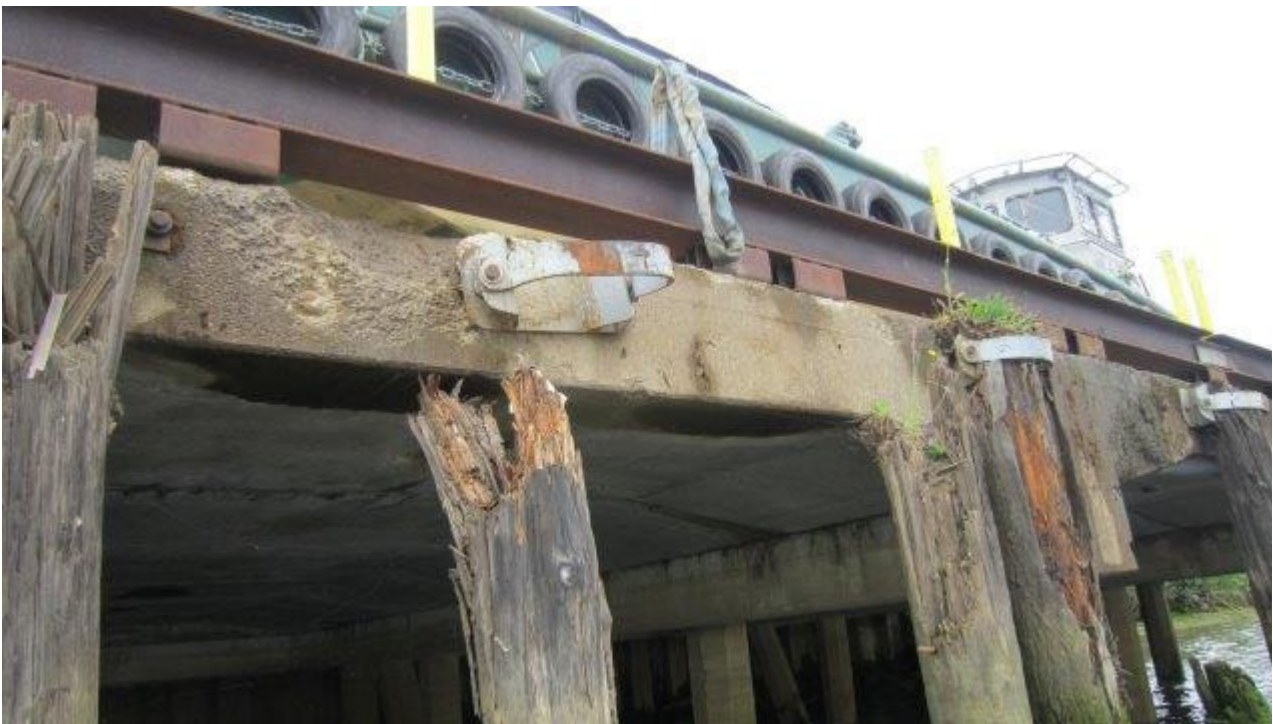
- Spall at the east face of both Pier 3 and Pier 4 decks. No exposed reinforcing or rust stains were observed (Photos 12 and 13).
- The concrete surface of the pier deck soffits appear to be in good condition (Photos 14 and 16).

Photo ST16-12: Pier 3 Pier Deck

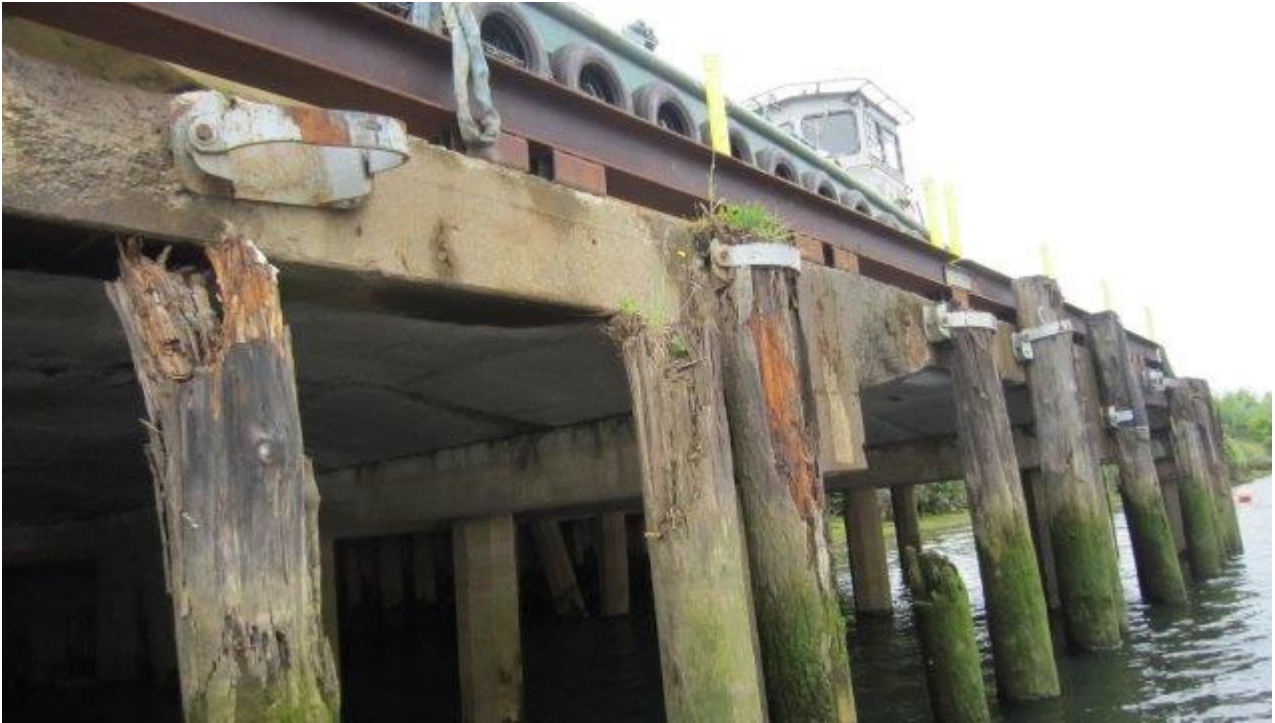
Photo ST16-13: Pier 4 Pier Deck

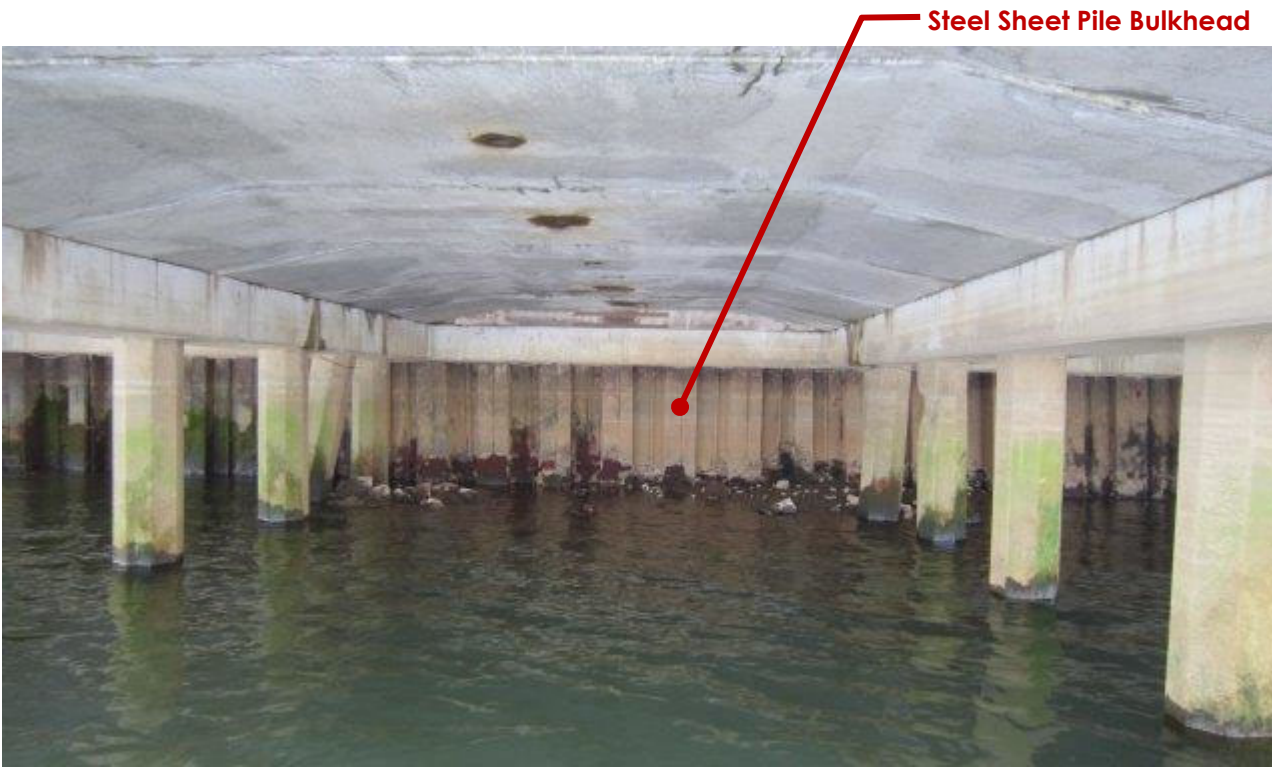
Photo ST16-014: Bulkhead and Pier Deck Soffit (Looking West)

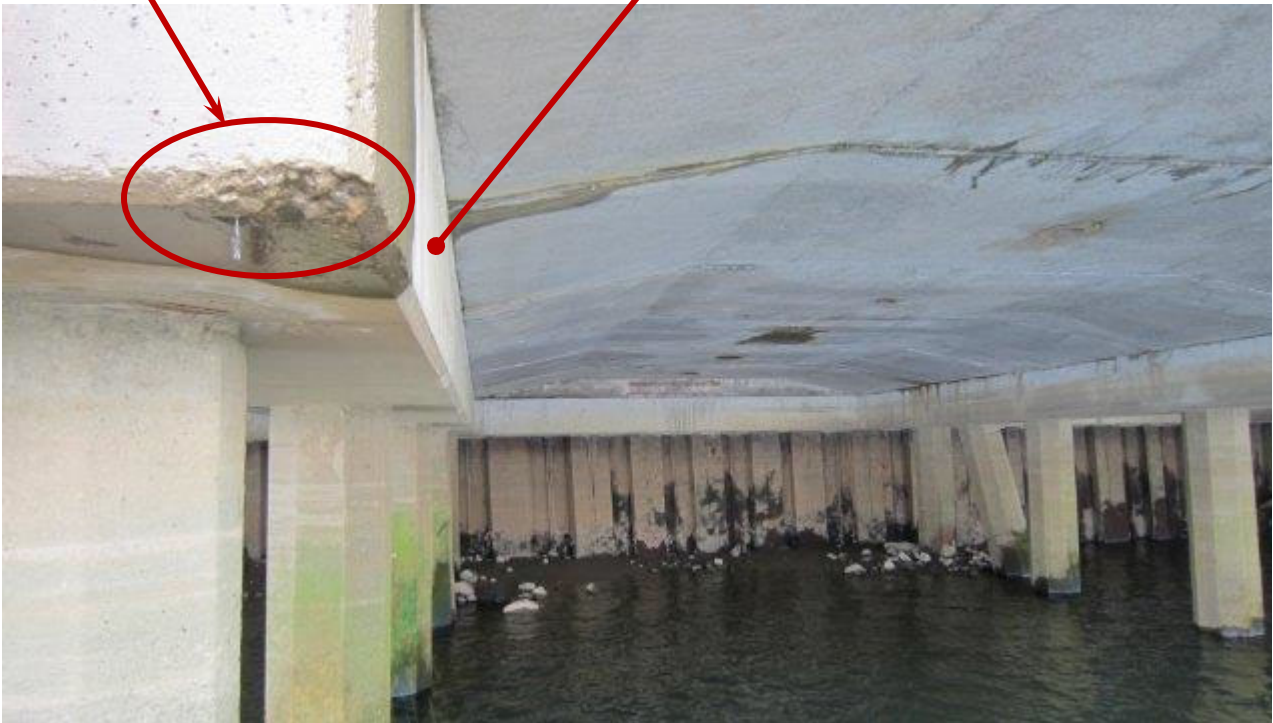
Minor Chip

Photo ST16-15: Pier Deck Soffit

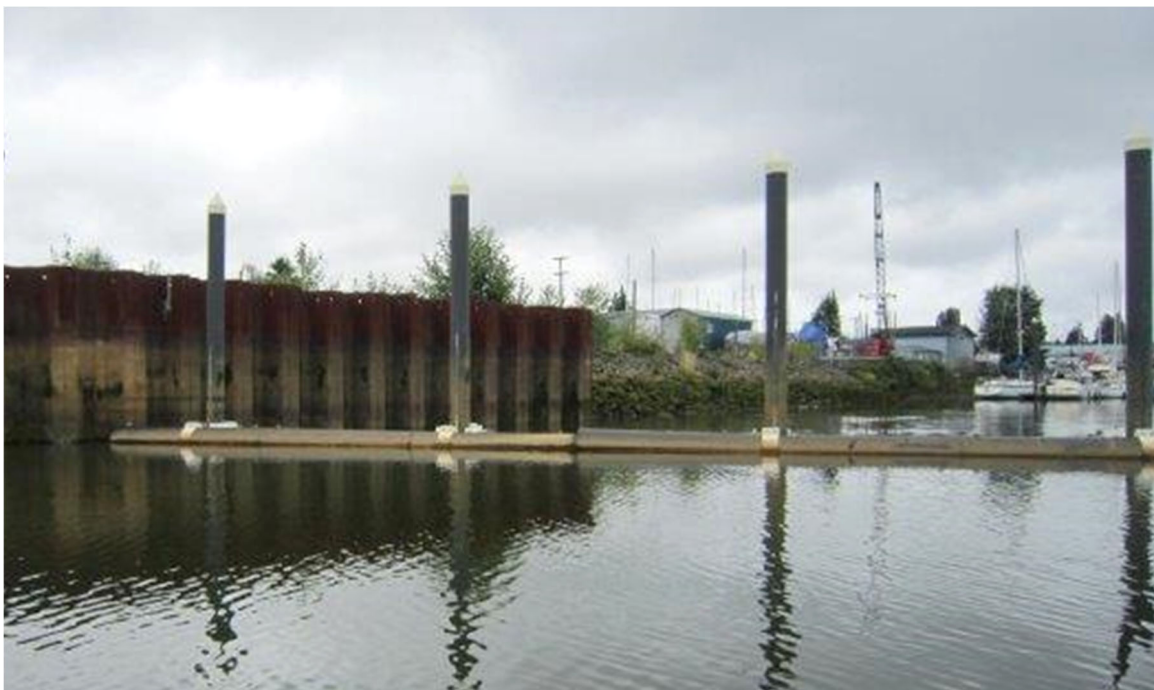
- Structure consists of U-shaped steel sheet pile bulkhead for contamination containment of Terminal 117 Cleanup Site.
- The sheet piles appear to be in good condition. (Photos 1 to 4)
- The North and South return walls abut riprap river bank embankment. (Photos 1 to 4)
- Near the north end of the bulkhead, four (4) 12" diameter steel pipe guide piles support for a 16" diameter float debris deflection pile pipe. The piles and float are in good condition. (Photos 2 and 3)
- During the July 12, 2021 inspection we observed, under construction, what appears to be an elevated concrete walkway deck supported by steel pipe piers. (Photo 5)
- The walkway is in-water, along the west shoreline and south of the South Park Marina.

Photo ST19-02: Debris Deflector Float (Looking Northwest)

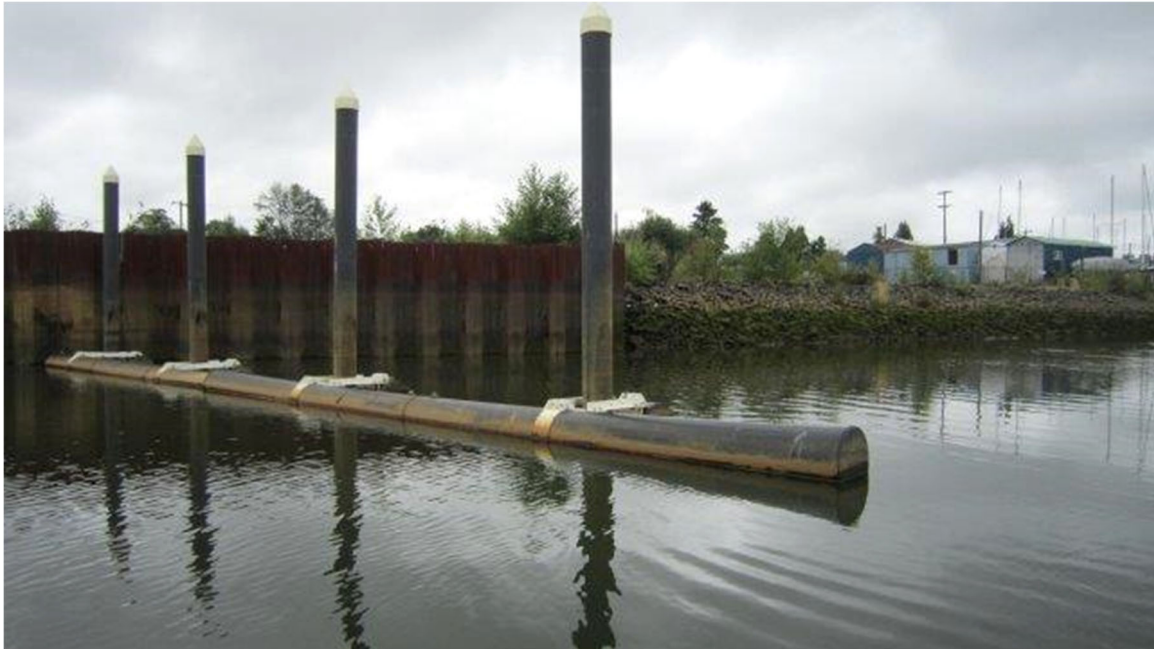
Photo ST19-03: Debris Deflector Float (Looking Northwest)
